# Gardner Division EMP

June 25, 2001 Site Visit

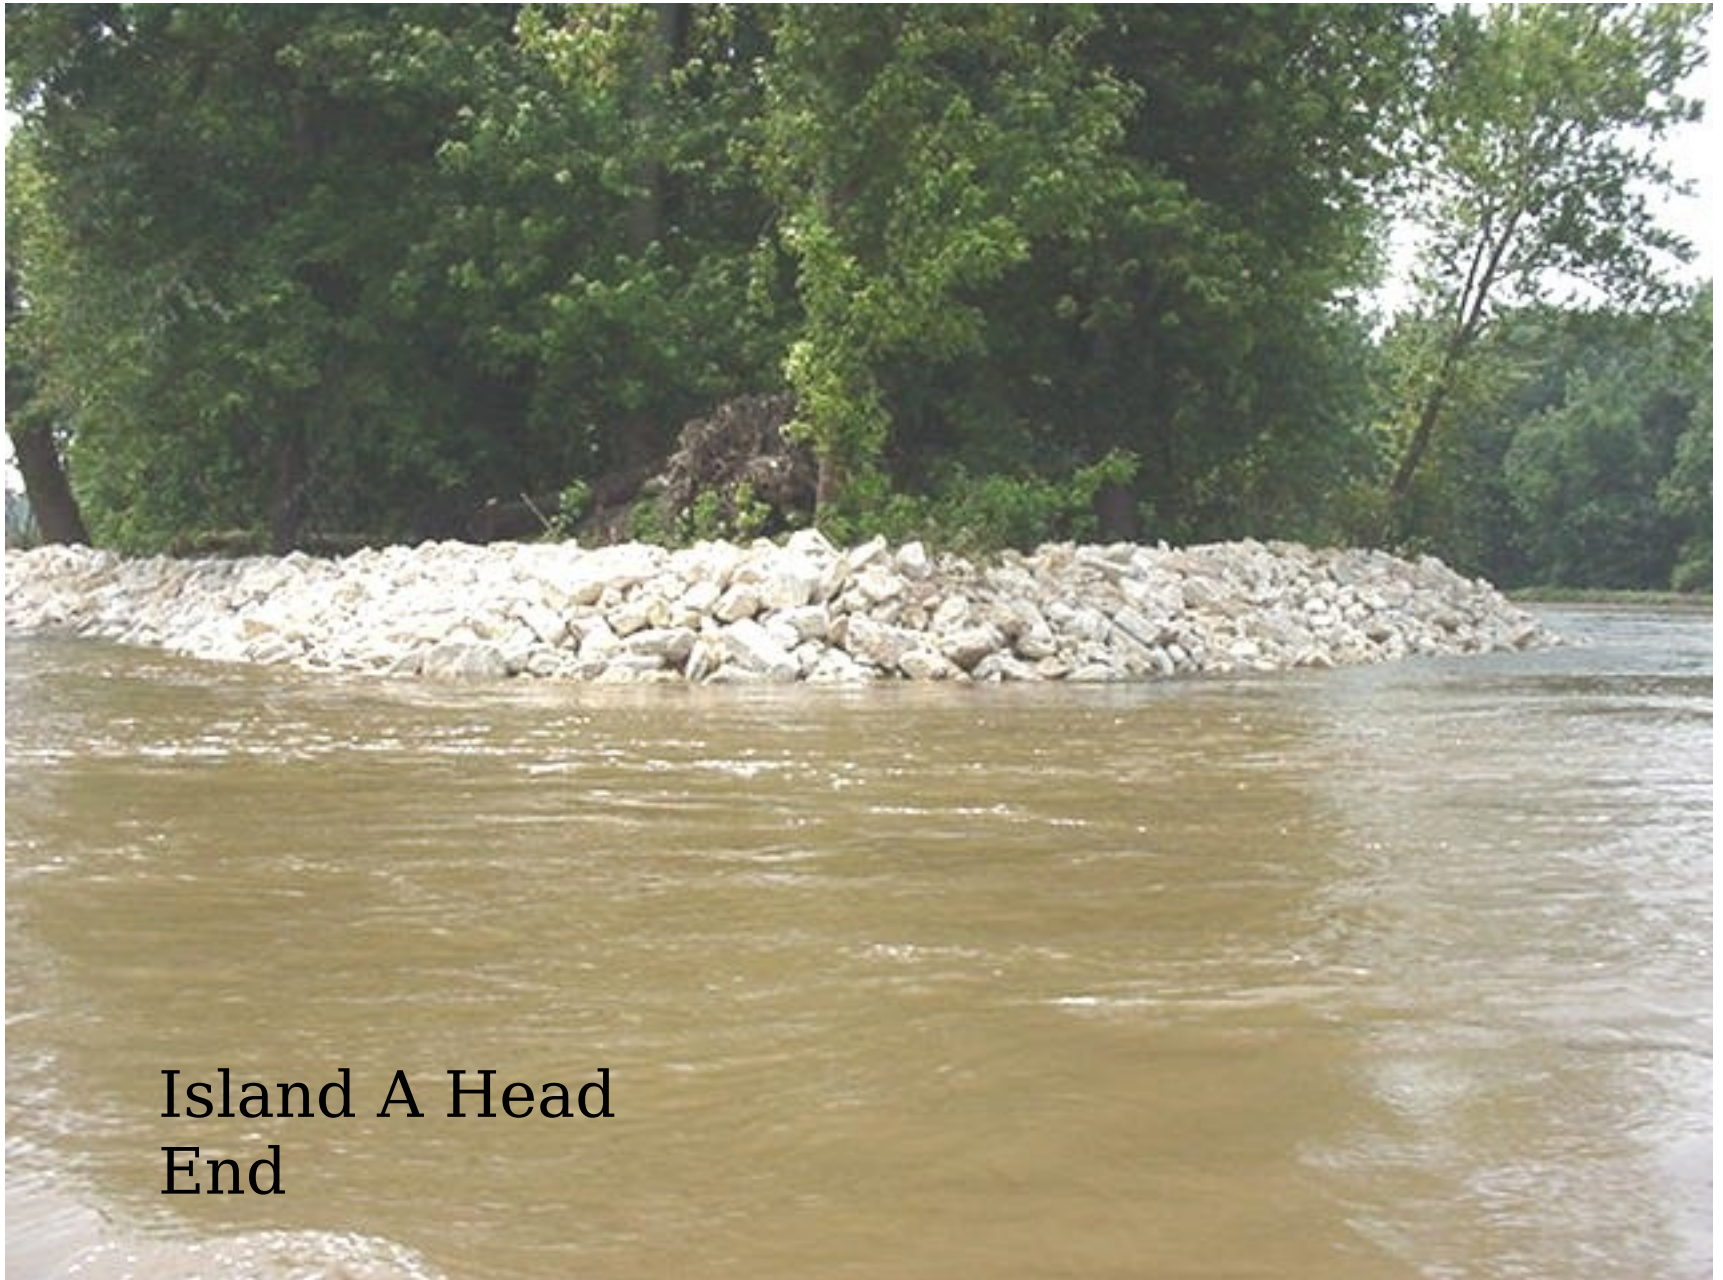
Island A Head  
End

- Limited Grading
- 10 feet had been cleared for tree removal, ~5 feet were lost to erosion from Flood.
- 6 inch minus and riprap in place, but not shaped.
- Final quantity: 3517 tons 6 inch minus (high), 2279 tons riprap (low)

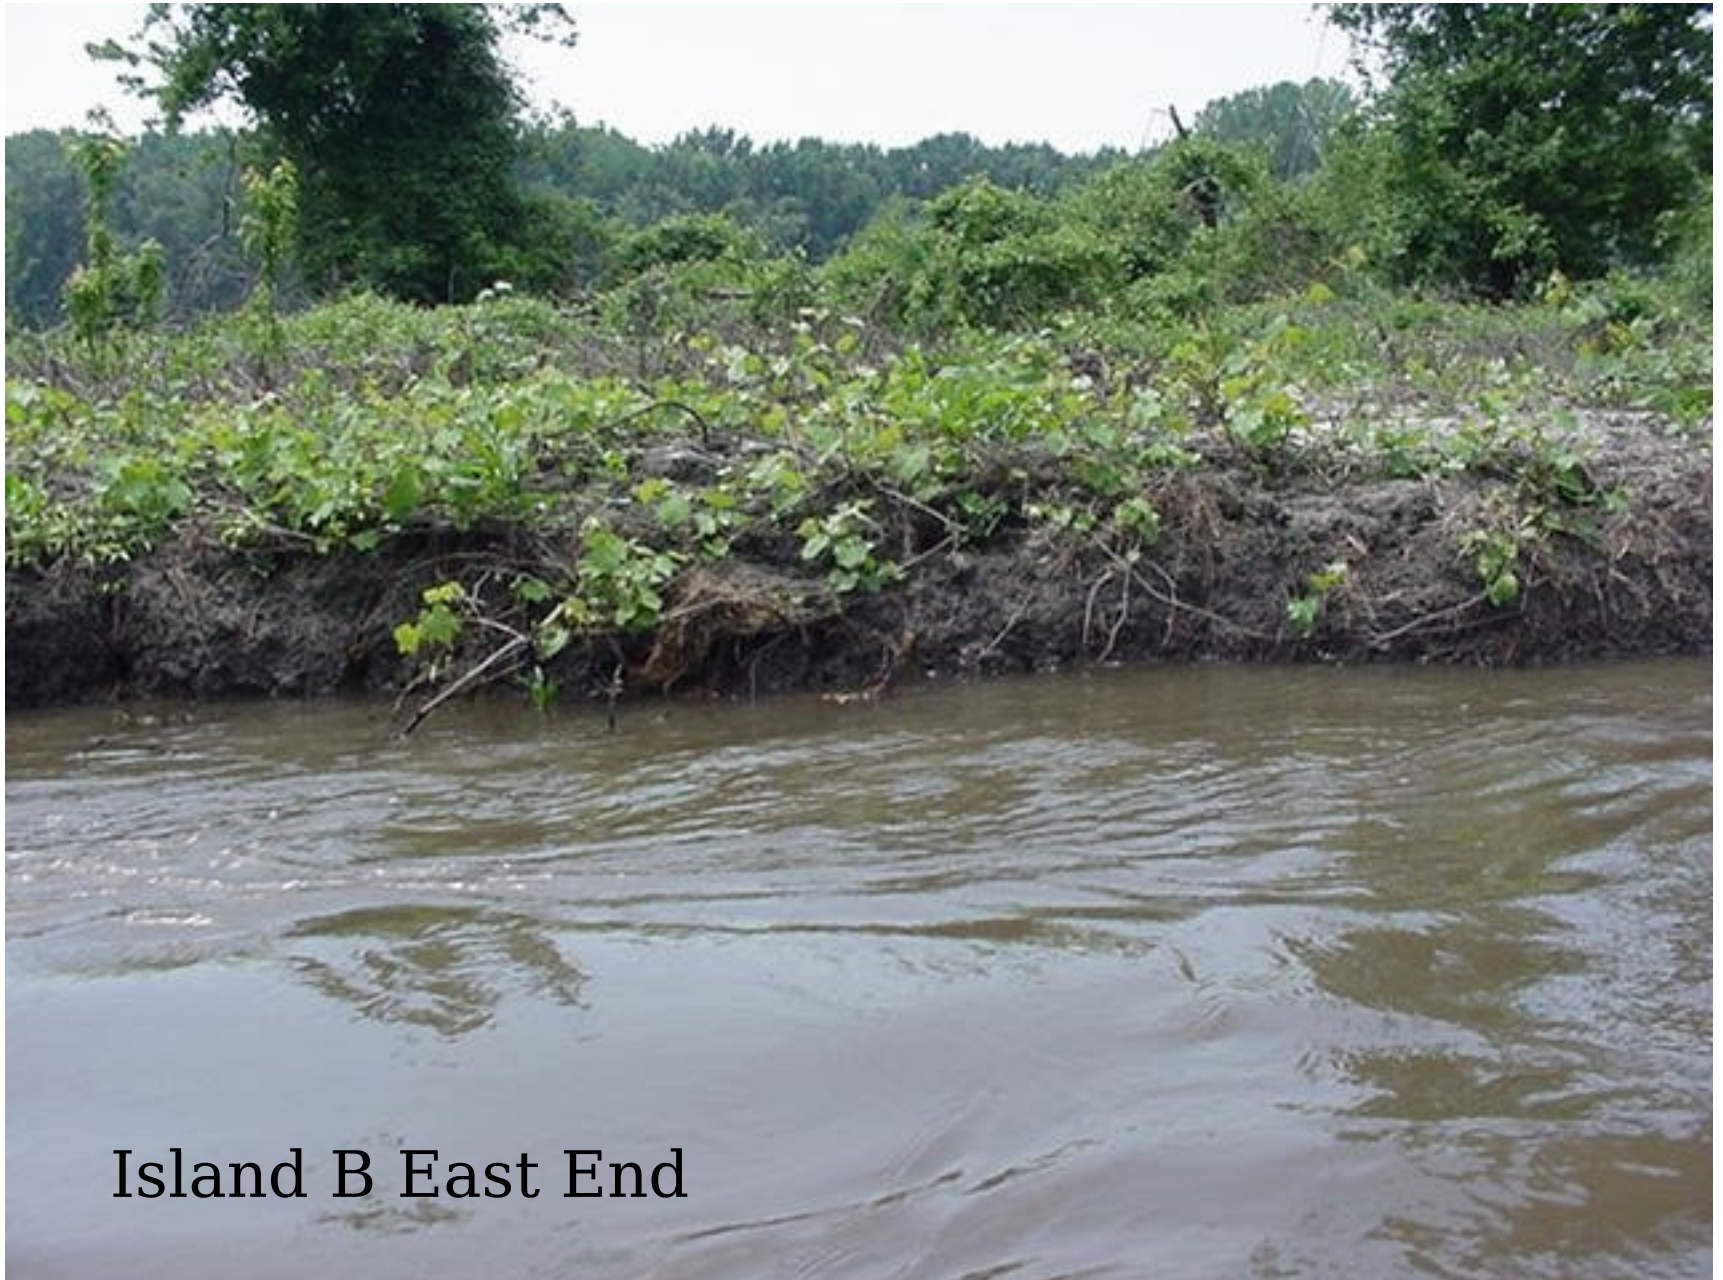
Island B East End

- Very little vegetation.
- Sandy material across head of island.
- Some erosion noted.
- Another area requiring rock fill.

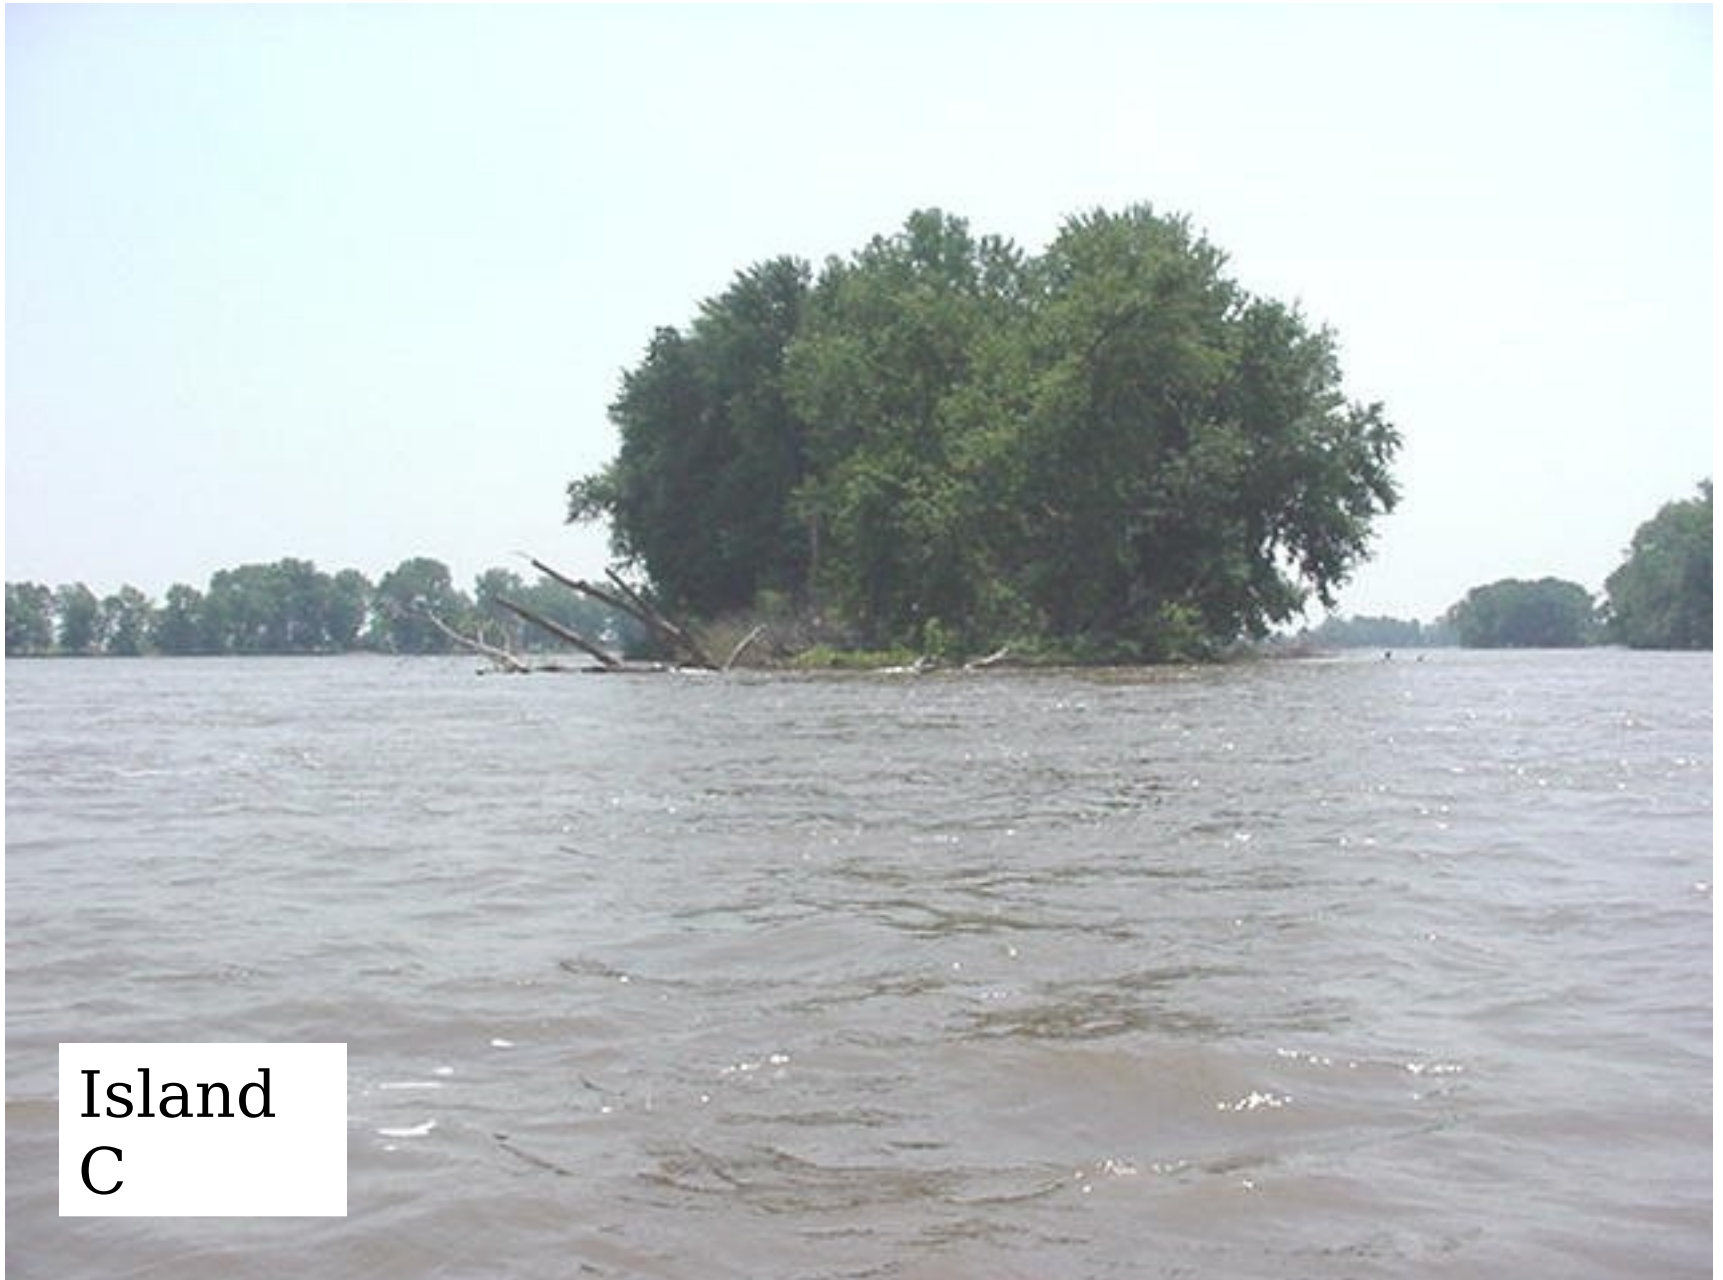
Island  
C

- Significant Erosion since tree clearing.
- High flows in area.
- More rock is anticipated to be required.
- Rock fill is required for this island.

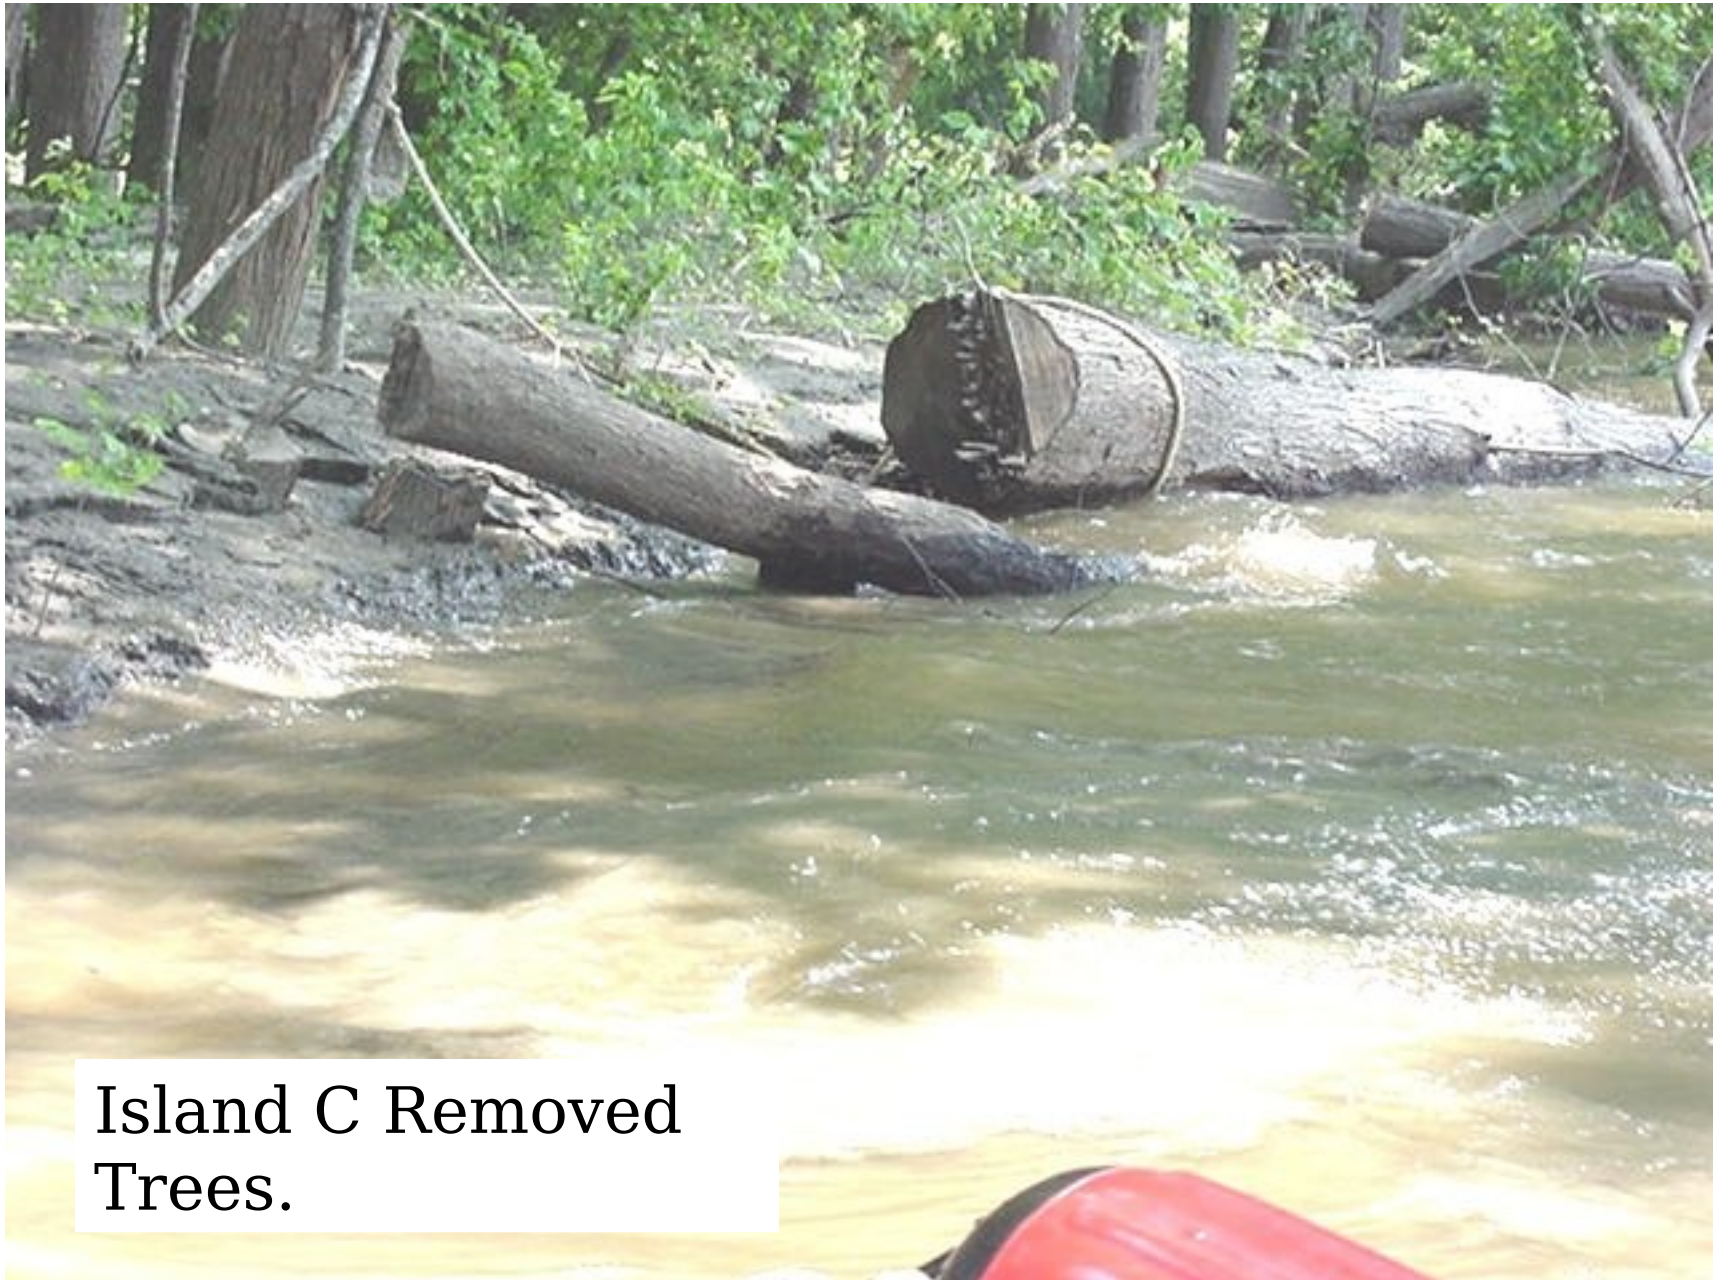
Island C Removed  
Trees.

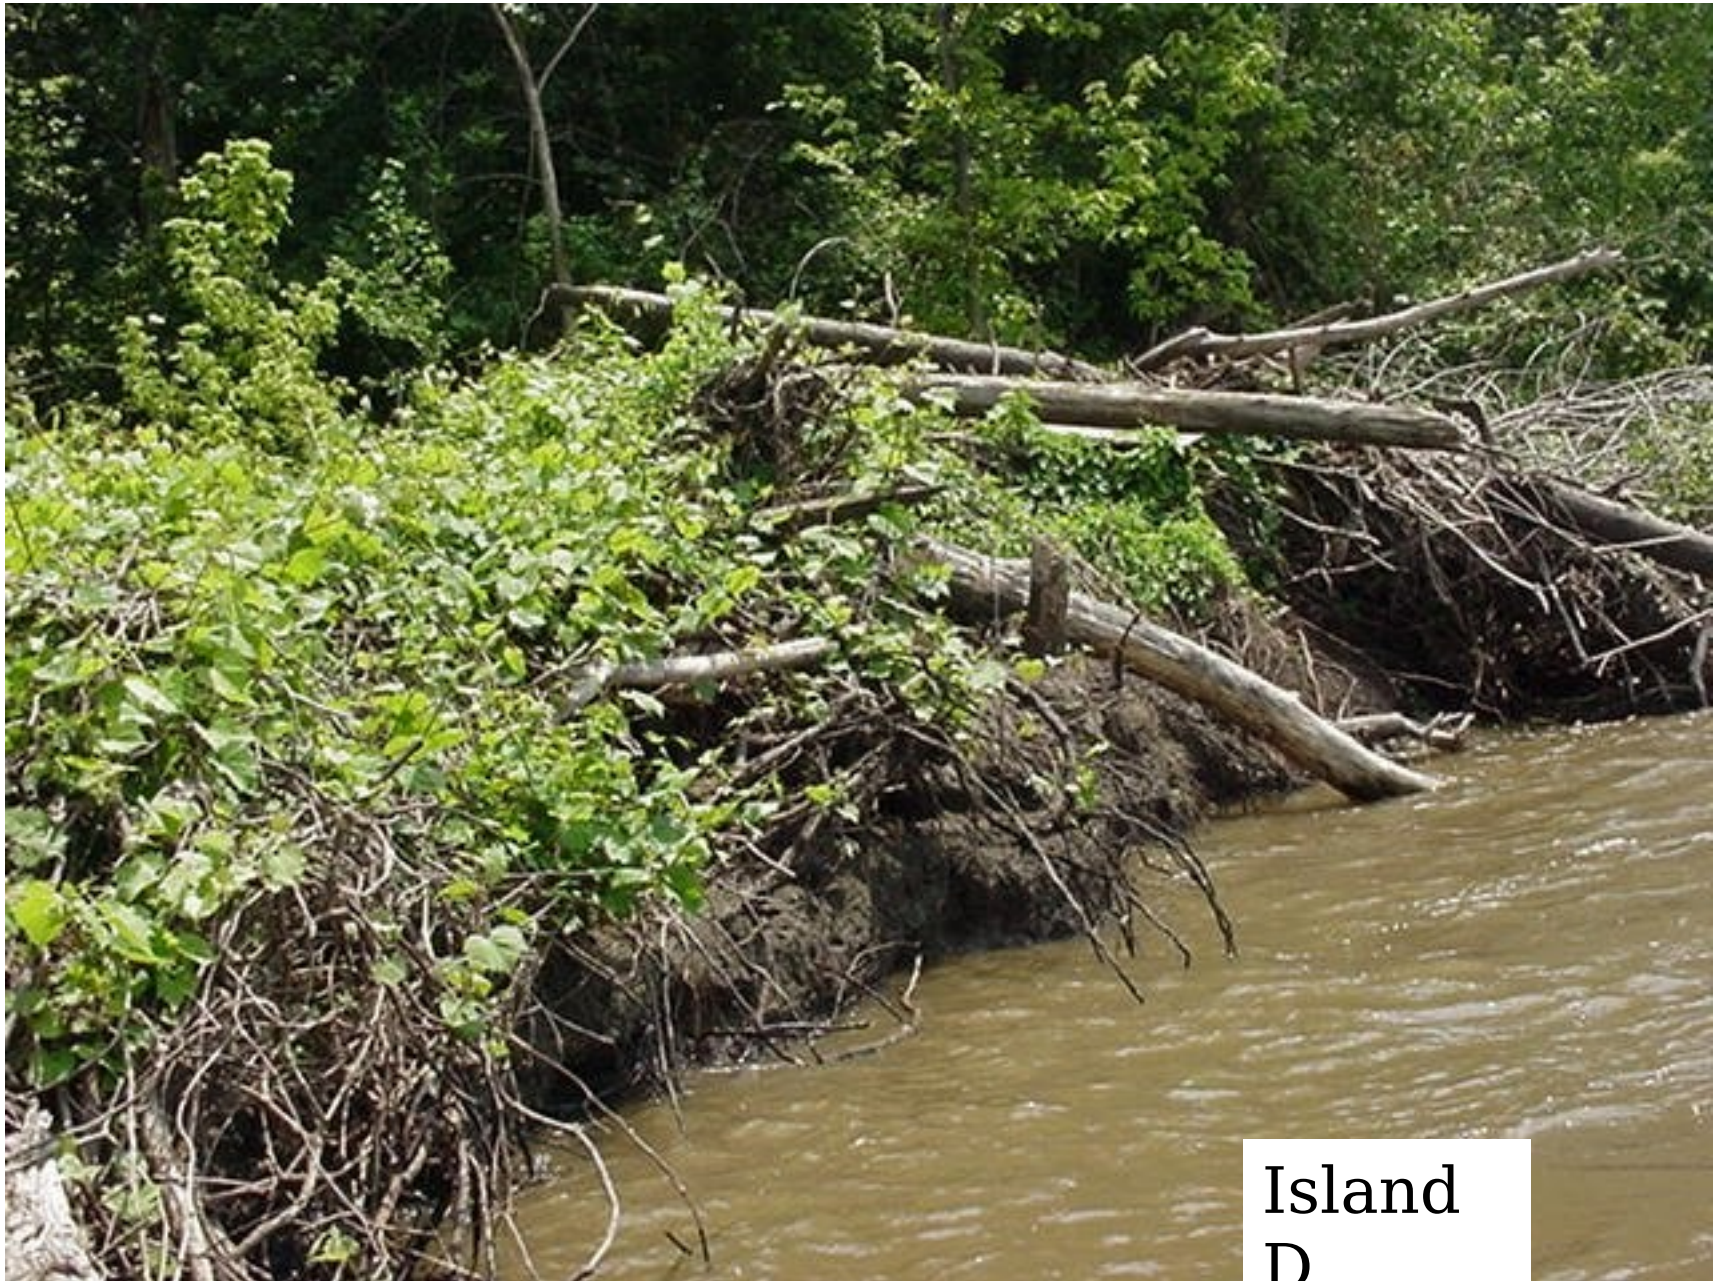
Island  
D

- Erosion not as evident at this island.
- Island is heavily vegetated.
- Depth finder discovered 7 feet depth at 18 feet from this Island.

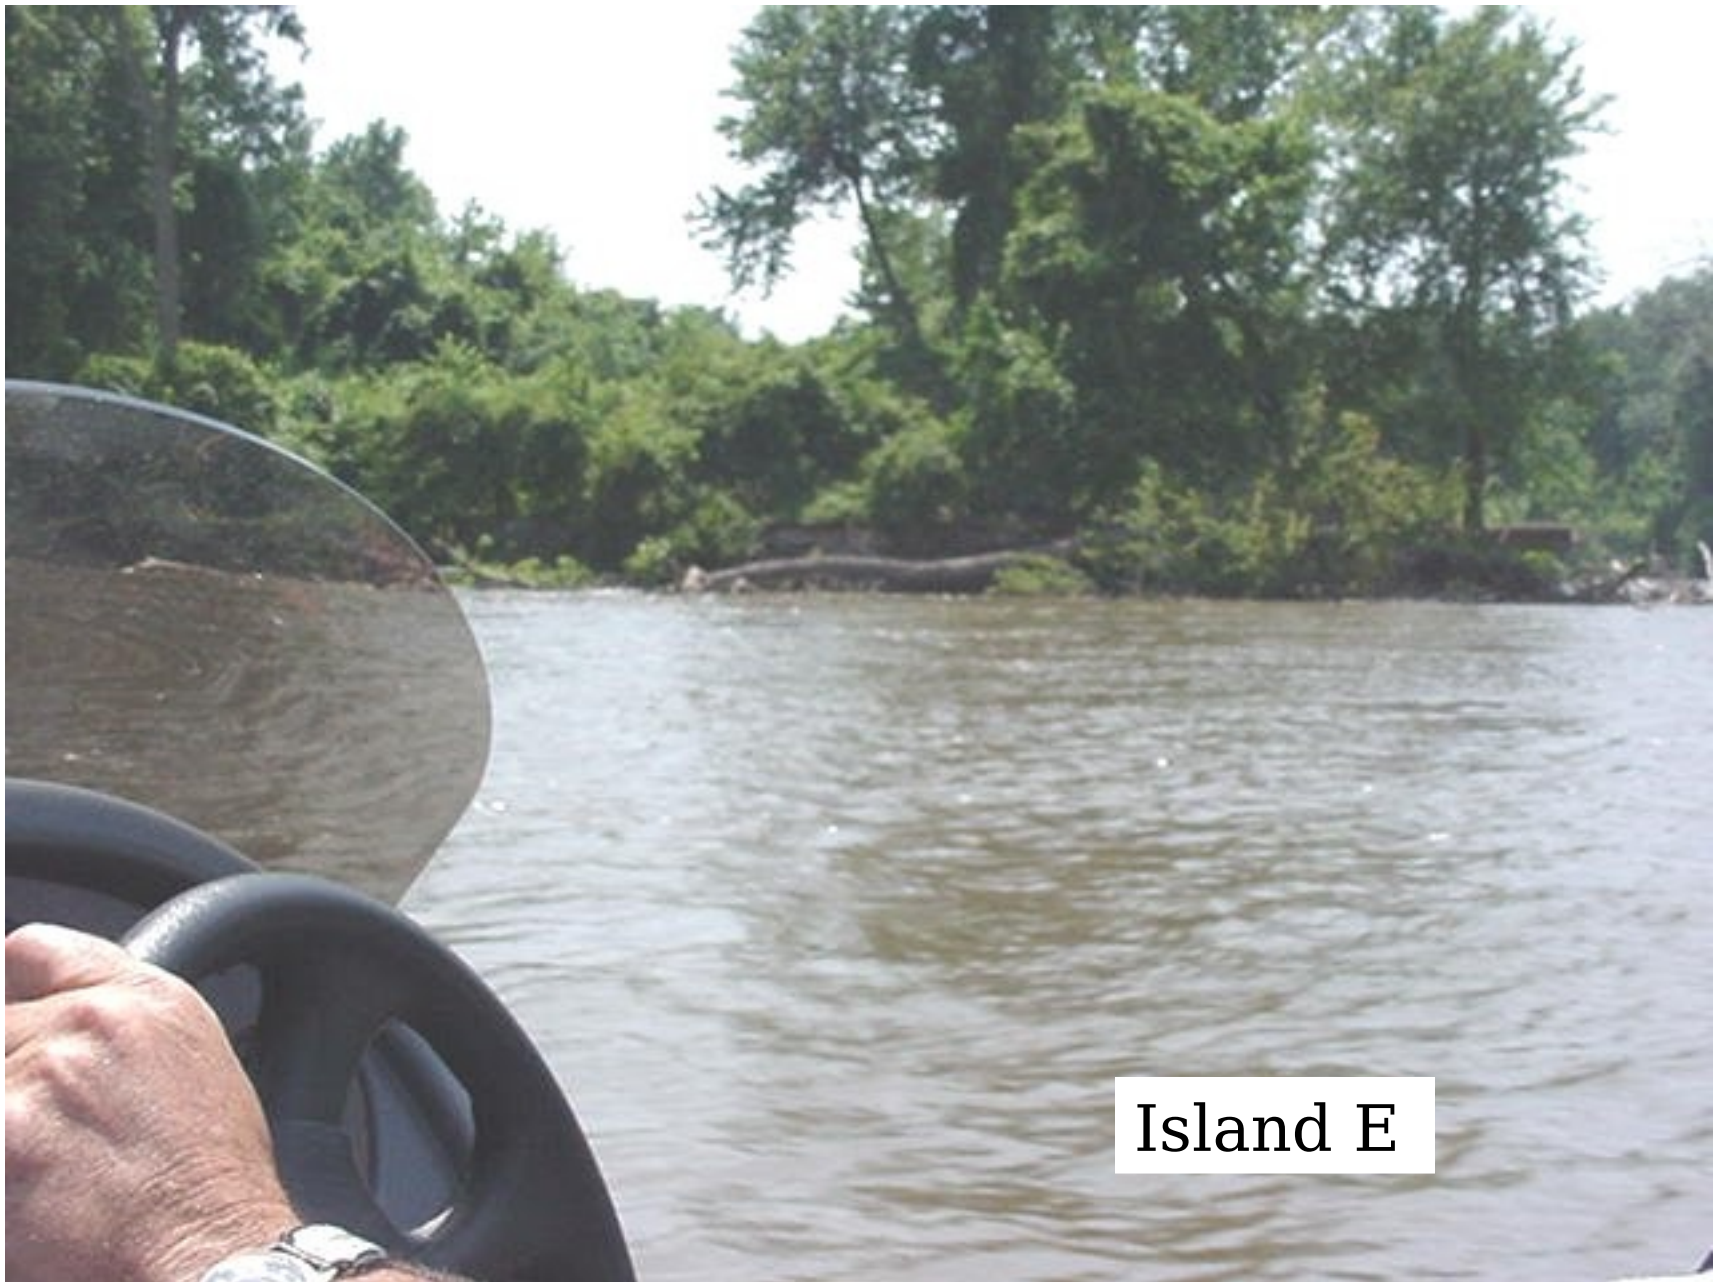
Island E

- Erosion is somewhat evident.
- This will be a difficult area to access due to rock structure just upstream.
- Depth finder found 7 feet depth at 18 feet from Island.

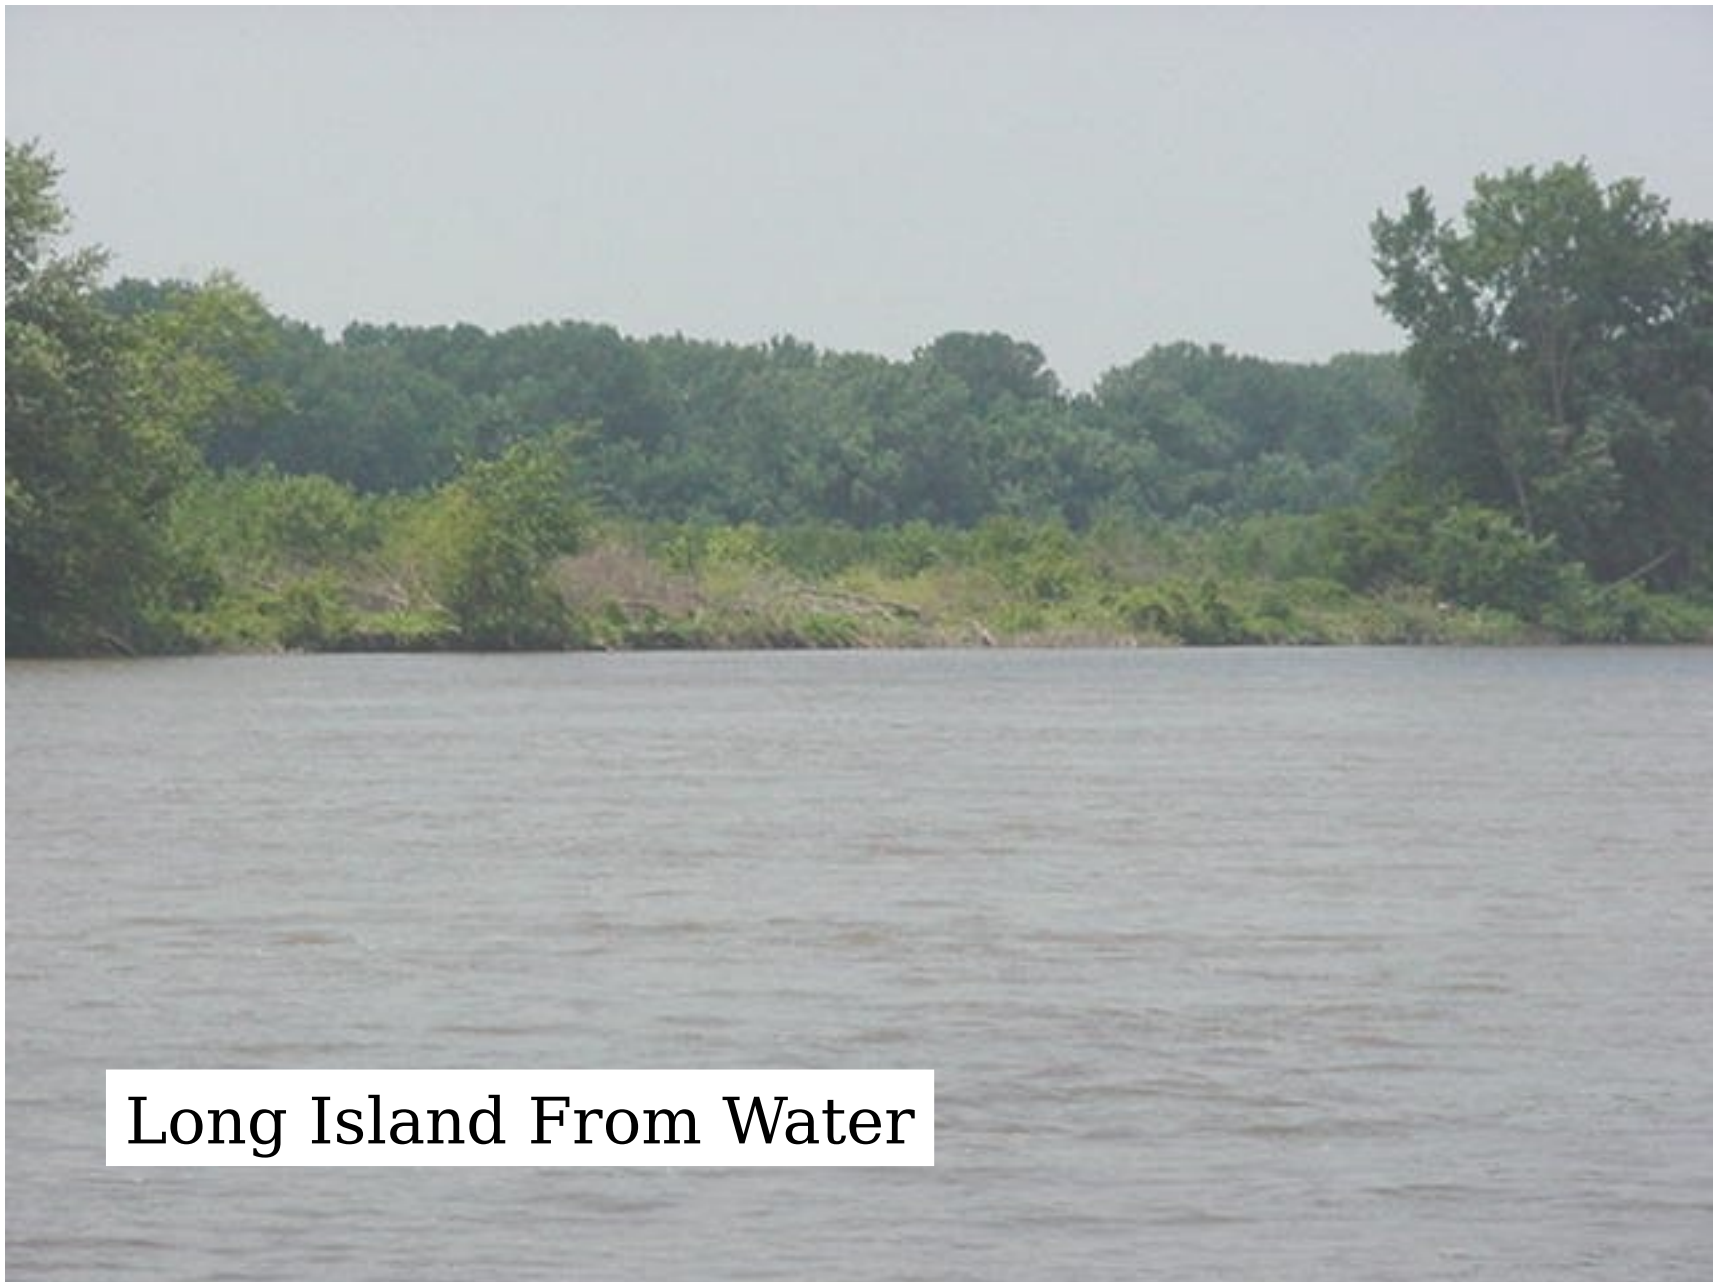
Long Island From Water

- Length of erosion has increased beyond original survey length of 495 feet.
- Significant scour has occurred at the toe of island. Around 20-30 feet at 18 feet from bankline.
- Significant additional rock will be required for this section.

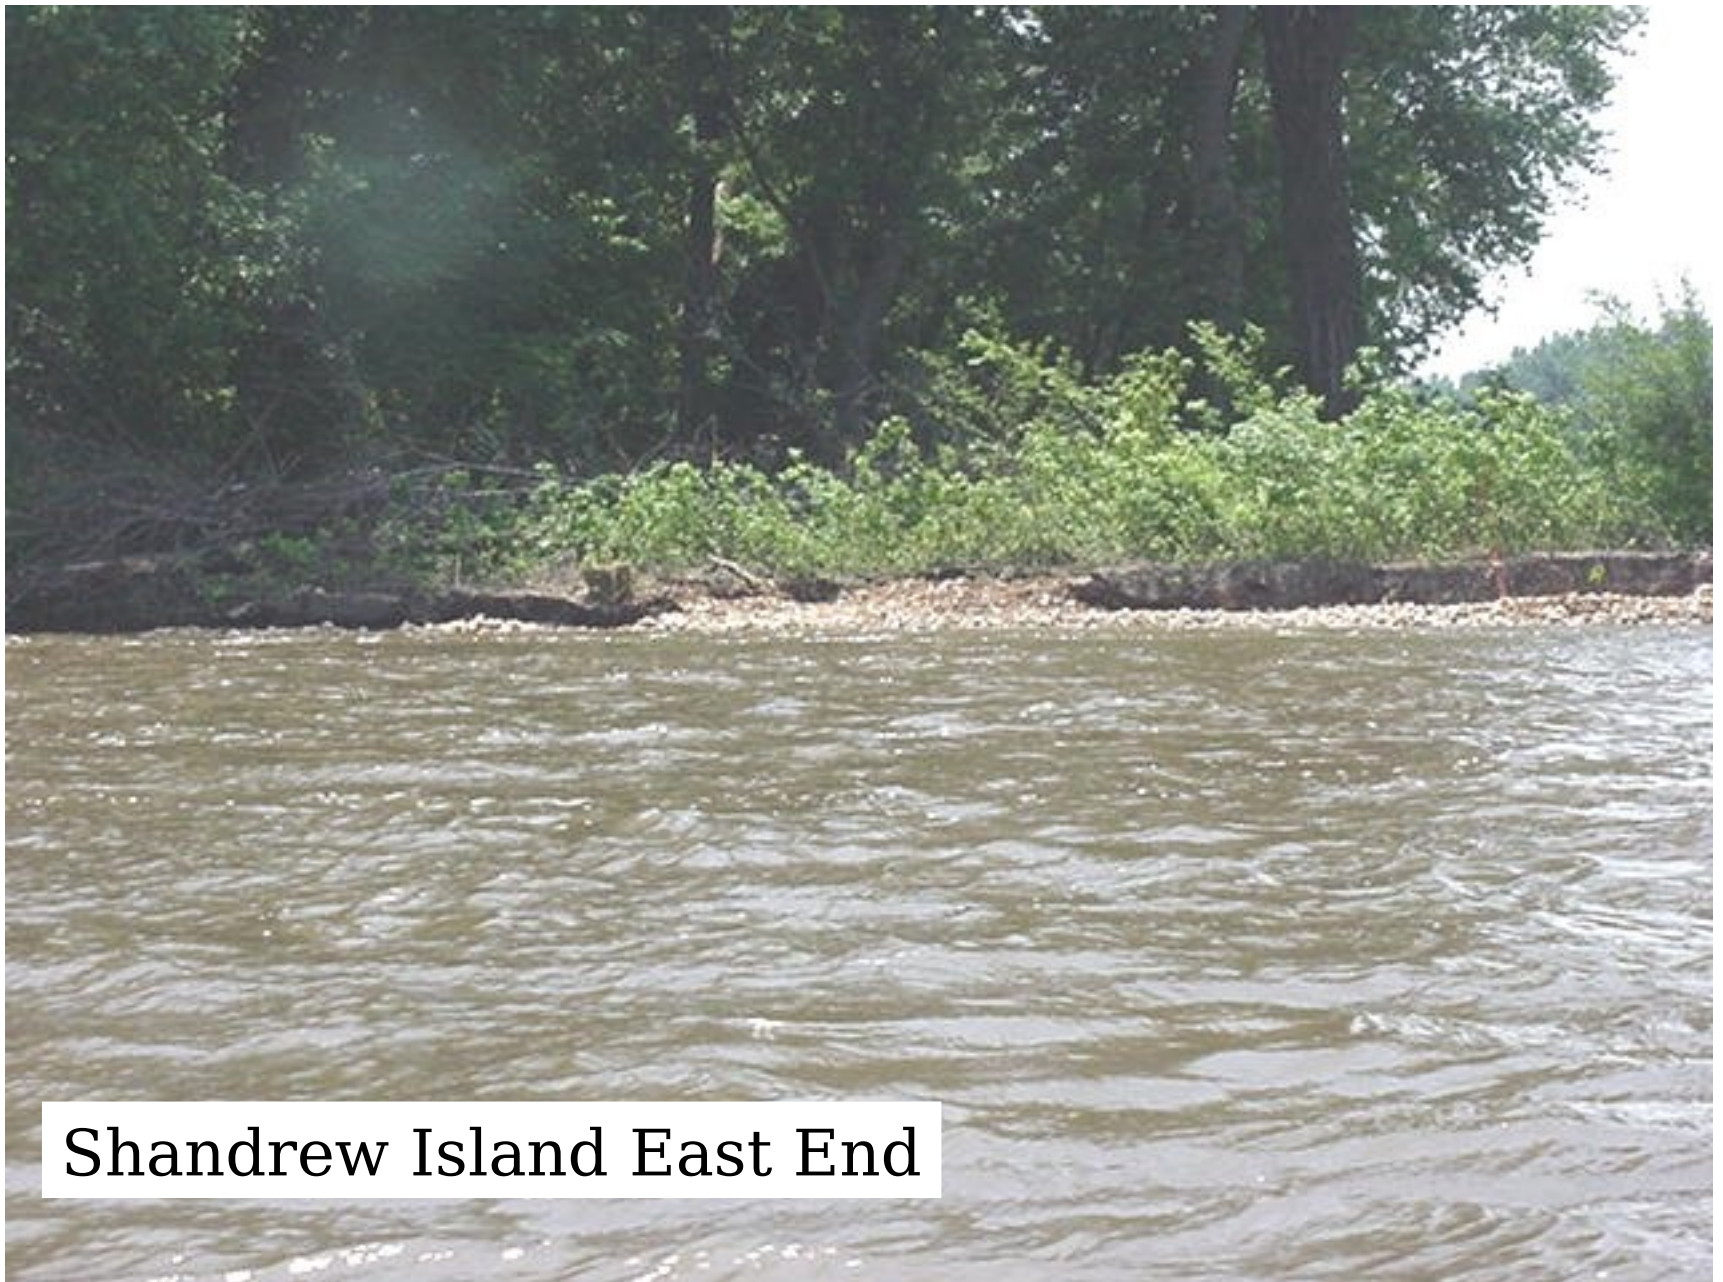
Shandrew Island East End

- Some 6 inch minus rock was in place.
- Riprap was about to be placed.
- Surface of 6 inch minus (to a depth of a few inches) was washing away.
- Significant fines in the 6 inch minus.
